SHOCK TUNNEL TESTS OF ARCHED WALL
PANELS

URS Research Company

Defense Civil Preparedness Agency

July 1974

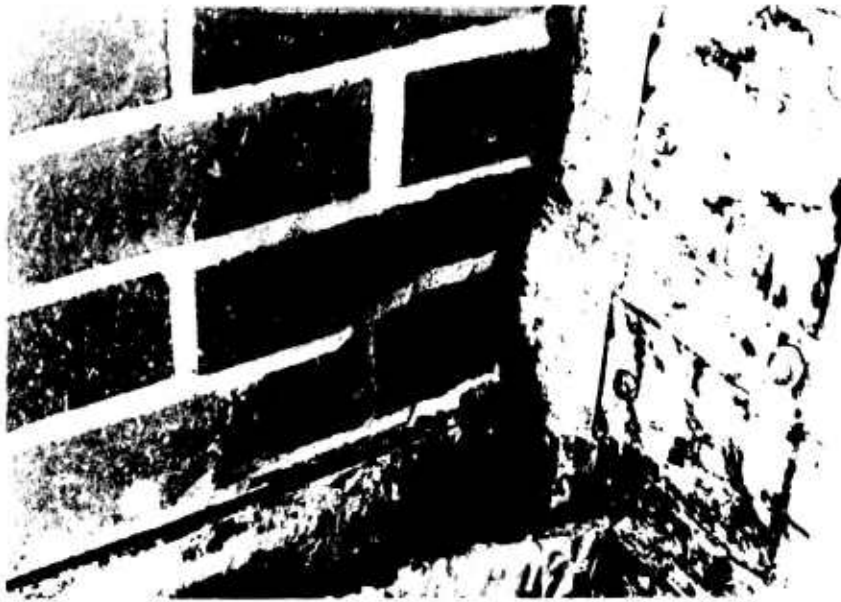
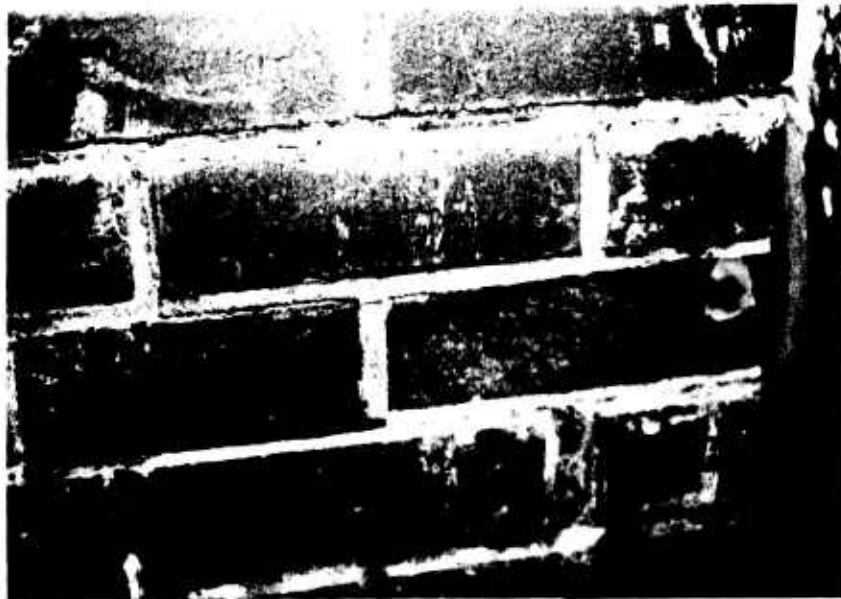
Fig. A-5. Post-Test Photographs of Wall No. 88

One test was conducted on this wall using six 60-foot strands of primacord (P_r approximately 16 psi) which catastrophically failed the wall spreading debris to 80 feet (the far wall of the casement) as shown in the post-test photograph in Figure A-7. Displacement gauge data for this test is presented in Figure A-8.

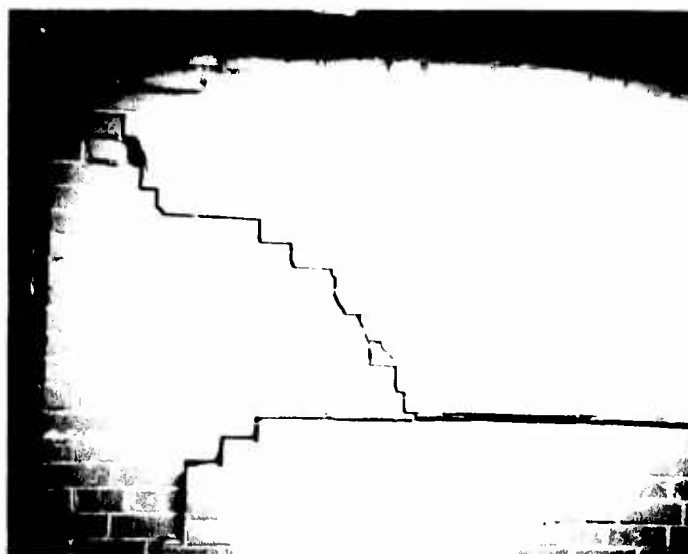
Fig. B-22B. Close-up of Cracking Towards Corners for Test Wall No. 24

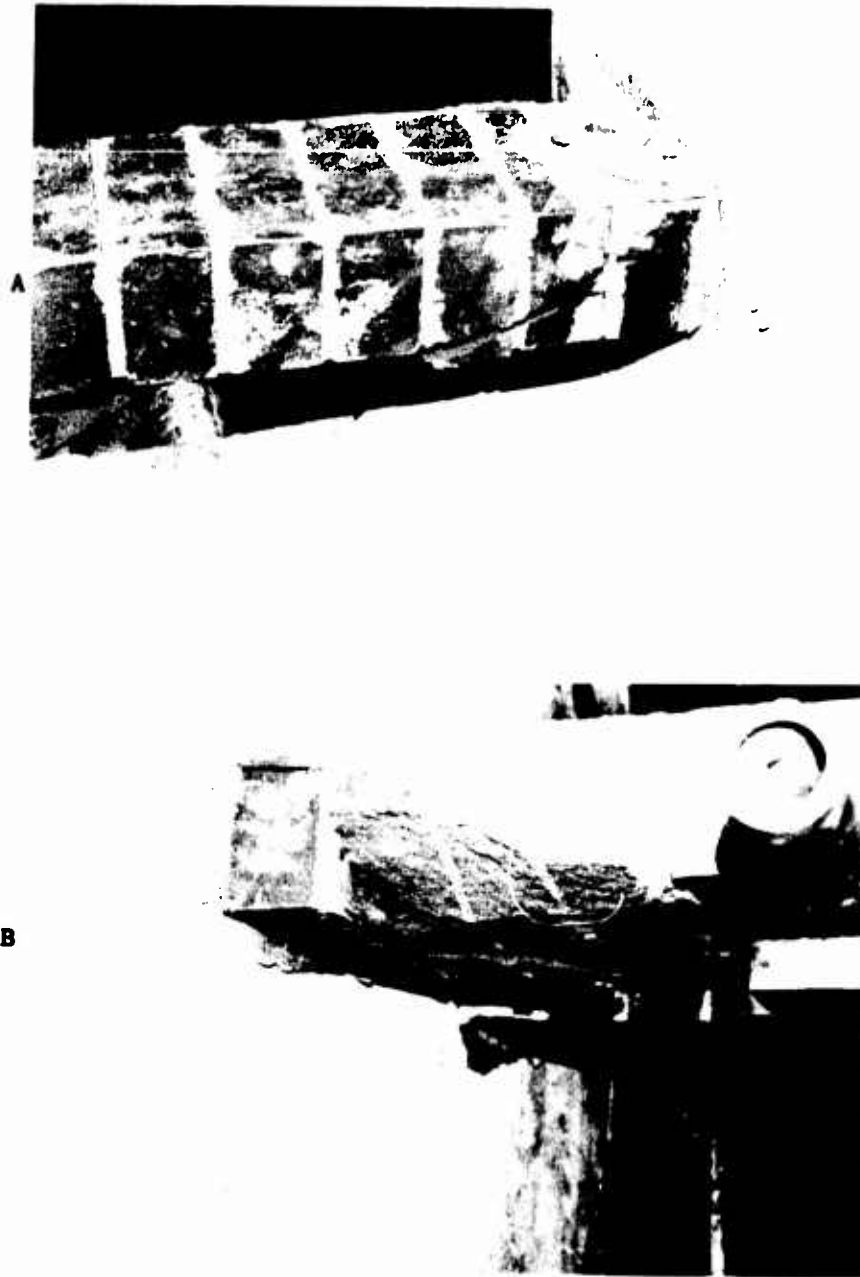
Fig. C-6. Typical Failure Crack Patterns Arched Brick Beams.

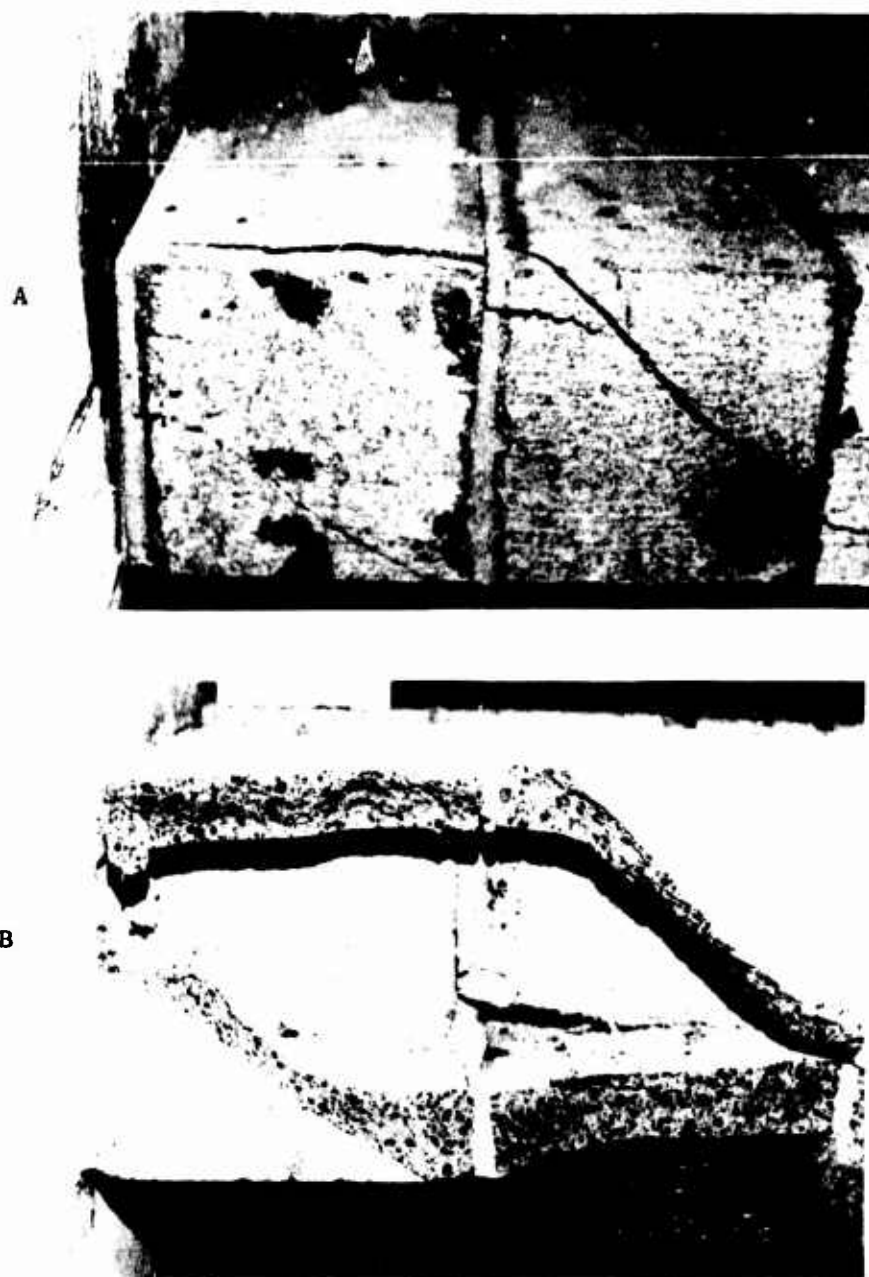
Fig. C-7. Typical Failure Concrete Block Arched Beam.
